Water System Master Plan

April 2022

PREPARED FOR:
Village of Pewaukee
235 Hickory Street
Pewaukee, WI 53072

PREPARED BY:
Ruekert & Mielke, Inc.
W233 N2080 Ridgeview Parkway
Suite 300
Waukesha, WI 53188

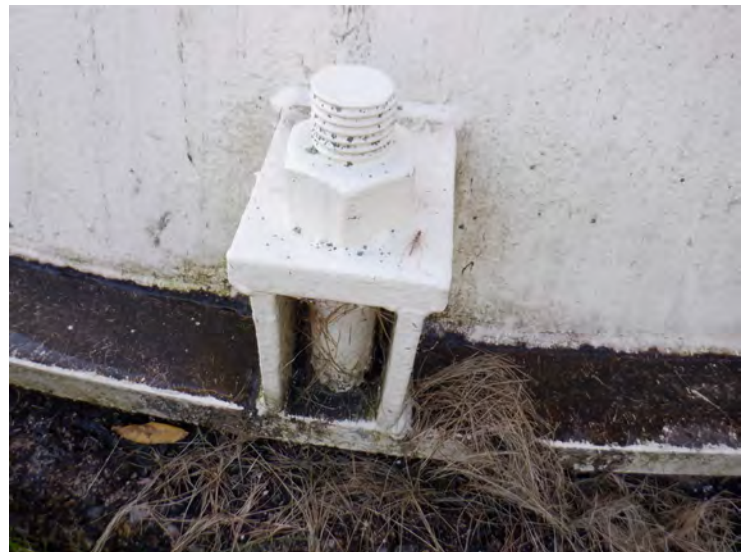
1) The concrete foundation is in good condition with no significant deterioration.

2) The anchor bolts are in good condition. There is no missing grout between the baseplate and foundation.

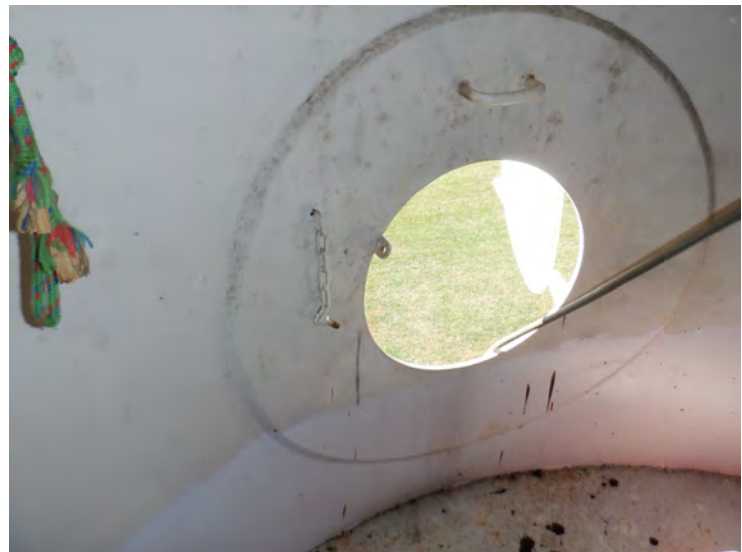
39) Minor coating failures on the top platform.

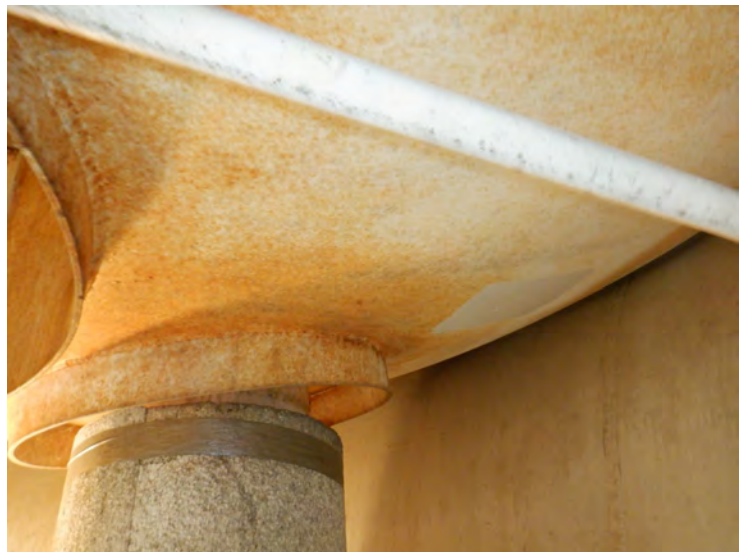
44) Extensive rust bleedthrough on the bowl.

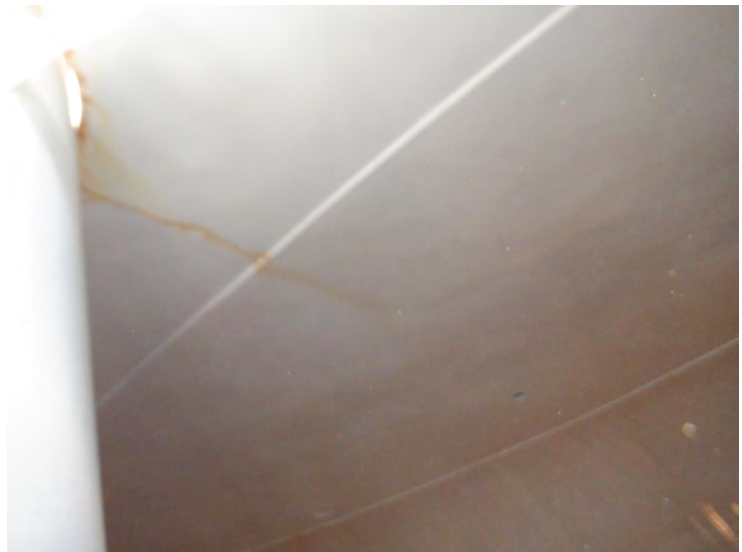
48) Coating failures on the wet interior manway.

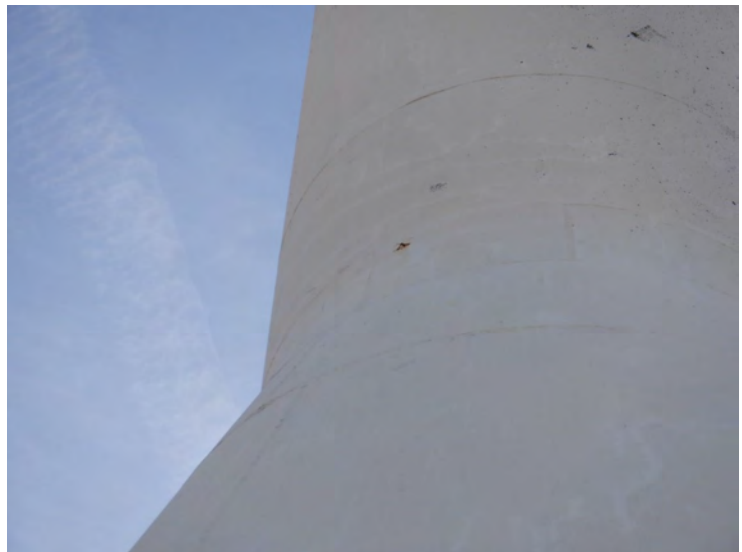
11) Coating failures on the riser.

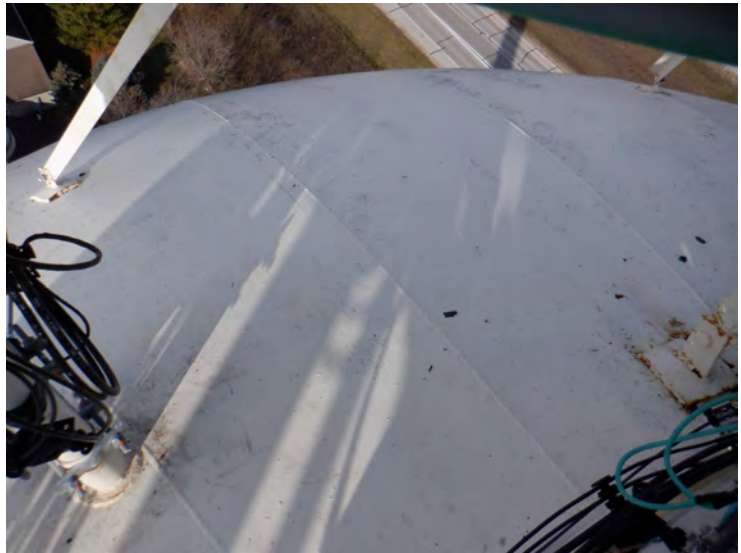
20) Coating failures on the roof.
