**NOTICE OF  
JOINT REVIEW BOARD MEETING  
REGARDING THE PROPOSED PROJECT PLAN AND DISTRICT BOUNDARY  
FOR TAX INCREMENTAL DISTRICT (TID) NO. 3  
IN THE  
VILLAGE OF PEWAUKEE, WISCONSIN**

**Village of Pewaukee  
Joint Review Board Organizational Meeting  
Regarding the Proposed Project Plan and District Boundary for Tax Incremental  
District (TID) No. 3 in the  
Village of Pewaukee, Wisconsin via Zoom  
February 9, 2021**

Property Condition Assessment Report

St Mary's Catholic Church  
449 West Wisconsin Avenue  
Pewaukee, Wisconsin 53072

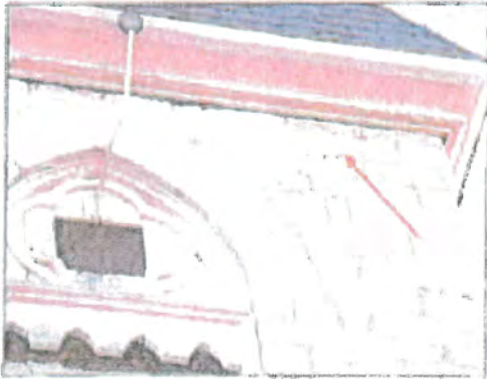
The exterior stone facades appear to be in overall fair condition. General tuckpointing is recommended throughout the field of the façade, with the chimney requiring more acute attention. Sealants throughout the building facades appear to be in overall good condition. Costs associated with repairing the belfry openings are included in the steeple roof repairs. An opinion of costs associated with replacing the basement windows are included in the table found in Section 1.3 Summary of Cost Data. Other costs fall below the given threshold of \$3,500.00 and are not itemized in this report.

9. Steeple mortar deficiencies

- Repoint deficient masonry joints using a lime rich-low Portland content mortar. TRC recommends using lime-rich pre-manufactured mortar mixes over hand mixing. In addition, TRC recommends the testing of existing historic mortars to determine a match with the dominant color and correct ratio of lime to Portland to sand. Test using ASTM C1324 Standard Test Method for Examination and Analysis of Hardened Masonry Mortar.
- Replace basement windows.
- Repair and paint the Cedar belfry openings.
- Repair and paint the wood perimeter case moulding around the main entrance.

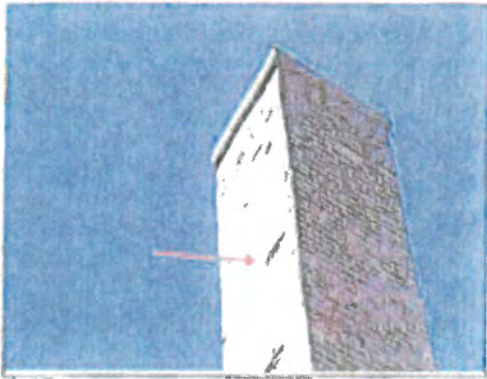
11. Masonry deficiencies on chimney

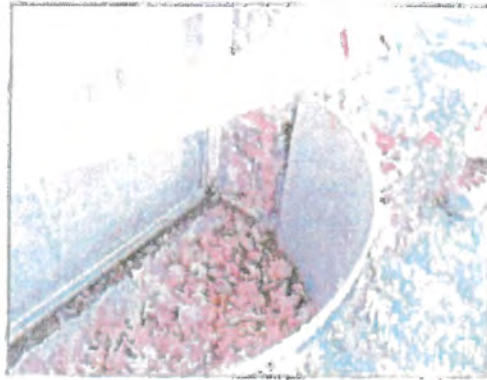
The wood-framed window and entry systems appear to be in overall good condition. However, the basement windows are in relatively poor condition due to moisture damage. There is exterior wood perimeter case moulding surrounding the main entrance that is in fair to poor condition. Observation showed severely deteriorated wood: splitting, and water damaged at the interface of wood moulding and concrete. The wood soffit elements are generally in good condition the exception being the gable ends where severe peeling of the paint was observed. In addition, the Cedar vented belfry openings showed were observed to be in poor condition with signs of wood weathering/deterioration due to severe peeling paint.

12. Rotted wood window West elevation of church.

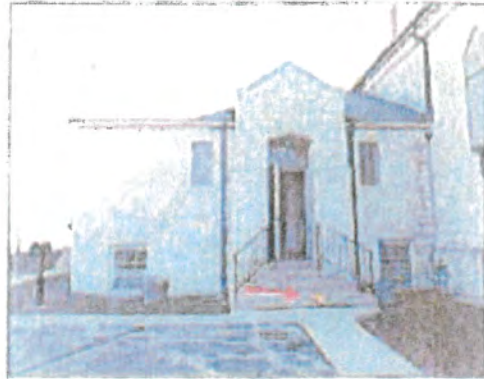
14. Annex entrance, south elevation. Note the trip hazard painted yellow

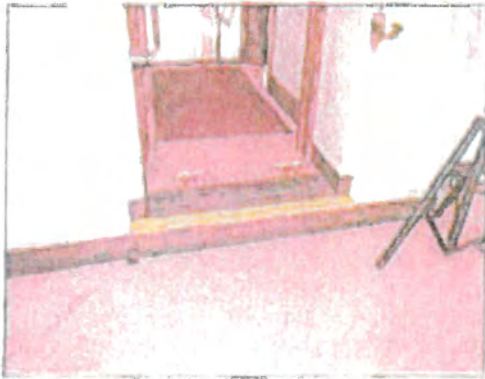
15. Change in floor elevation from church into annex

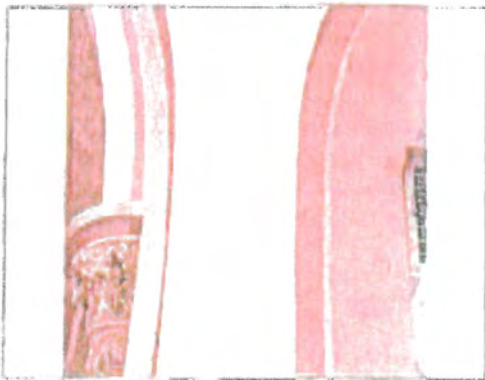
Typical interior spaces include finishes consisting of acoustical ceiling systems, recessed light covers, vinyl tile, painted drywall partitions and painted plaster. Interiors observed, appear to be in overall fair condition with some notable exceptions due to the suspected presence of mold and lead in the plaster of the church building and mold in some of the drywall located in the basement under the main building. Further, TRC observed significant cracking in the plaster walls and ceiling of the church building. The suspected environmental conditions will

It is TRC's opinion that the cracks in the plaster are not related structural movement of the building as it sits today. They are most likely associated with the addition to the basement during the 1953 construction. Plaster of this kind is applied by craftsman to a lightweight wood lattice system. Once the plastering is complete, it in effect becomes monolithic and quite rigid. From the arches out into the field of the ceiling the entire plaster system is supported by the wood lattice system which is mechanically secured to hidden timbers using nails. Due to the weight of cured plaster, additional reinforcement is needed in the transition from vertical wall out into the arches to prevent collapse of the ceiling. This is usually accomplished in several ways using a combination of heavy gauge wire, galvanized rod and vertical wood slats secured to horizontal trusses within the scissor truss system in the attic space. When the building was jacked up to facilitate installation of the new basement and it's supporting foundation and walls; it is likely there was some minor sway in the ceiling and arches, some of the vertical reinforcement may have broken, stretched or become miss aligned and it is also very likely there was some settling of the new foundation after the church building was lowered. These were all possible contributing factors to the cracking observed in the plaster, particularly the plaster was not supported diagonally in the attic space

17. Typical of cracks in plaster.

or at the transition from vertical to arches and ceiling. Due to the nature of the client's requirements for immediate cost, TRC does not recommend further investigation. Suspected mold and lead contamination are addressed in the following sections: 3.2.25 Limited Visual Lead Assessment and 3.2.26 Limited Mold Assessment.

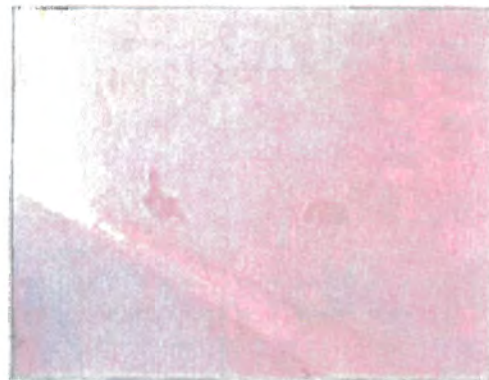
18. Typical of paint peeling from plaster surface

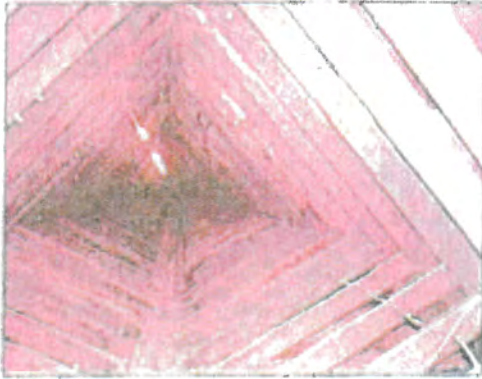
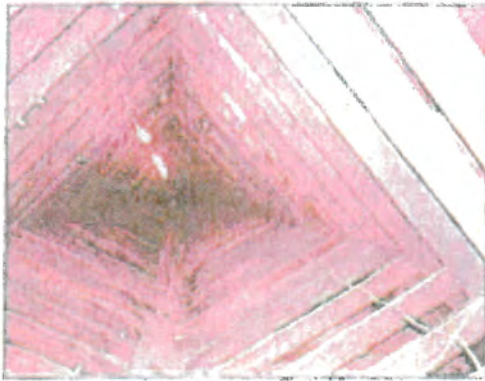
The building structure appears to consist of a multi-wythe Lannon stone construction including perimeter and interior heavy timber wood columns, wood hammer beams in the arches, and timber joists supporting the wood plank roof deck. The perimeter building walls are assumed to include wood studs with stone veneer. In the attic space, scissor trusses are arranged in a diamond configuration with wooden plaster strapping affixed to horizontal joists. The building frame appears to be in overall good condition. There were no visible structural deficiencies observed that require repair.

19. Scissor trusses in the church attic

31 Scissor trusses in the church attic

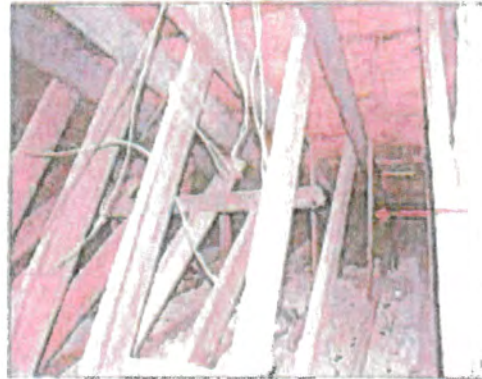
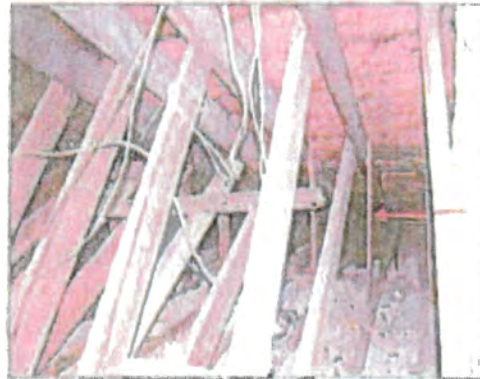
20. View into attic perimeter. Note vertical plaster supports

32. View into attic perimeter. Note vertical plaster supports

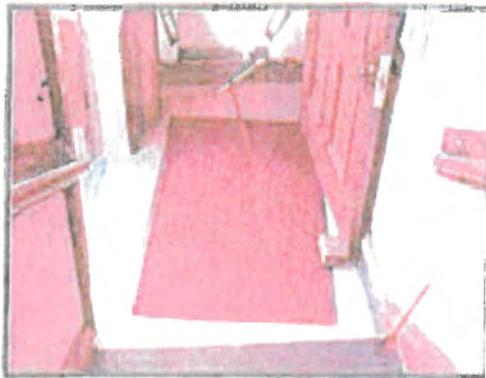
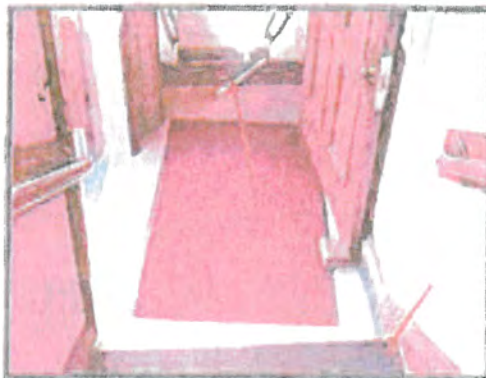
23. Annex entry is below floor line of church (foreground) with stairs leading to basement.

35. Annex entry is below floor line of church (foreground) with stairs leading to basement.

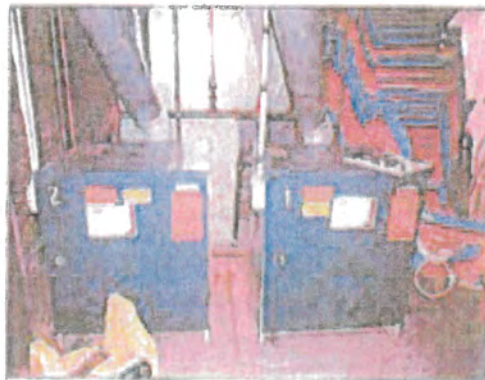
The EUL of gas-fired boilers generating hot water for building heat is typically 30-years depending on how well they are maintained. Based on the age, current condition, and EUL, replacement is not anticipated during the term. A current inspection sticker was observed mounted to the boiler.

24. Mechanical room, twin Vaillant boilers.

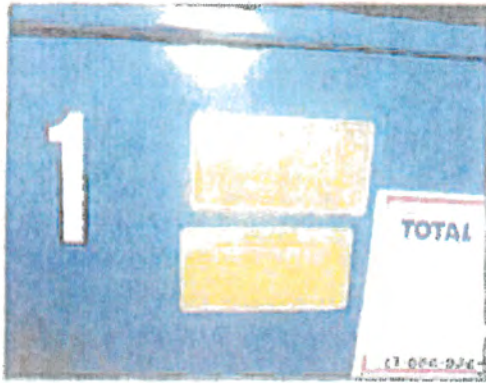
25. Boiler #1 inspection date

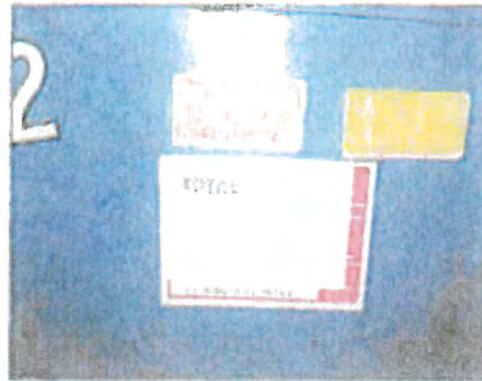
26. Boiler #2 inspection date

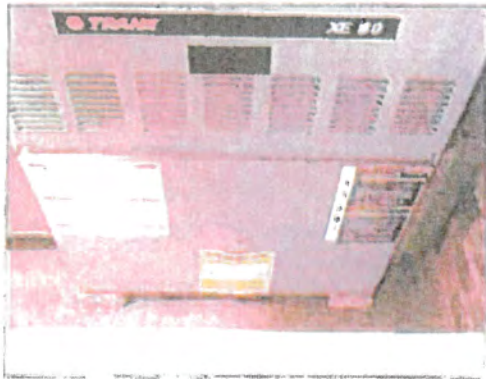
Heating, ventilation, and air conditioning (HVAC) throughout the building interior is provided via two Trane XE80 high efficiency gas furnace units installed circa 1996. These units are controlled with two thermostats located just outside the kitchen area. In addition, two Series 100 gas-fired heating boilers manufactured by Vaillant and installed in 1989 supply heat to the main church building. (It should be noted the Vaillant is a European manufacturer that pulled out of the U.S. market in 1995.) All of these systems are located in the mechanical room. Insulated hot water piping is distributed throughout the building to each of the VAV control units. Conditioned air is supplied through sheet metal ducting and ceiling diffusers. There were no A/C units observed.

27. TRANE gas fired furnices (2)

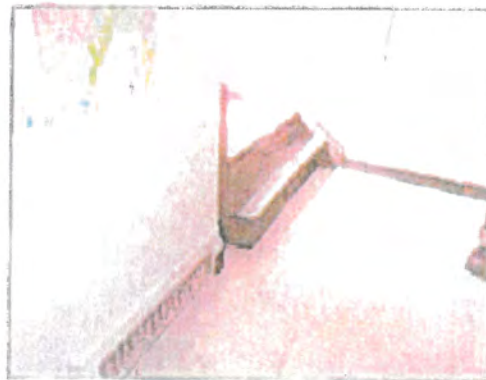
No vertical transportation or elevators were observed during the site visit. In order to achieve the client's accessibility goals, TRC recommends installing new two-stop hydraulic elevator, an elevator pit to accommodate the hydraulic workings and an elevator room. An opinion of costs associated with the installation of a new hydraulic elevator system are included in the table found in Section 1.3 Summary of Cost Data.

30. Stairs as only access to basement level.
