Water System Master Plan

April 2022

PREPARED FOR:
Village of Pewaukee
235 Hickory Street
Pewaukee, WI 53072

PREPARED BY:
Ruekert & Mielke, Inc.
W233 N2080 Ridgeview Parkway
Suite 300
Waukesha, WI 53188

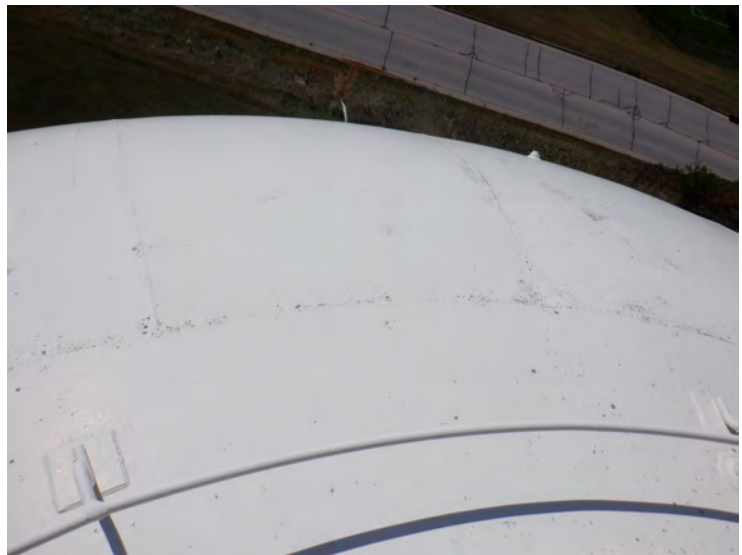
15) Same.

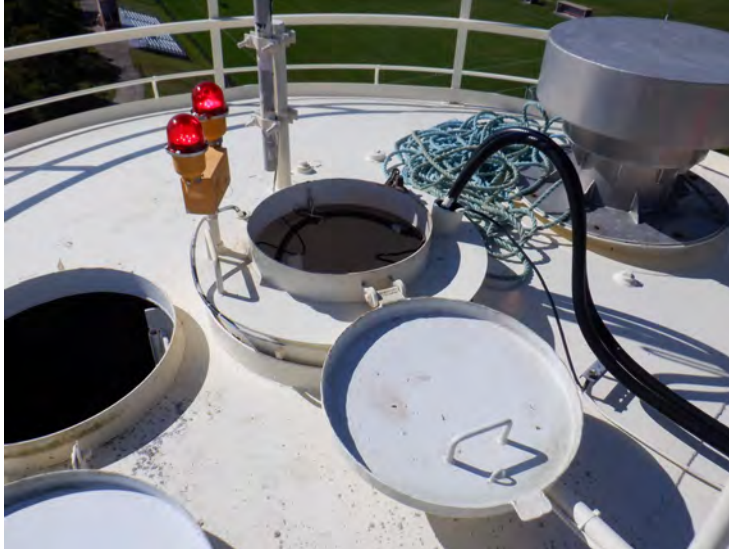
19) The dry interior roof hatch is in good condition.

20) There is no cover over the access tube air gap.

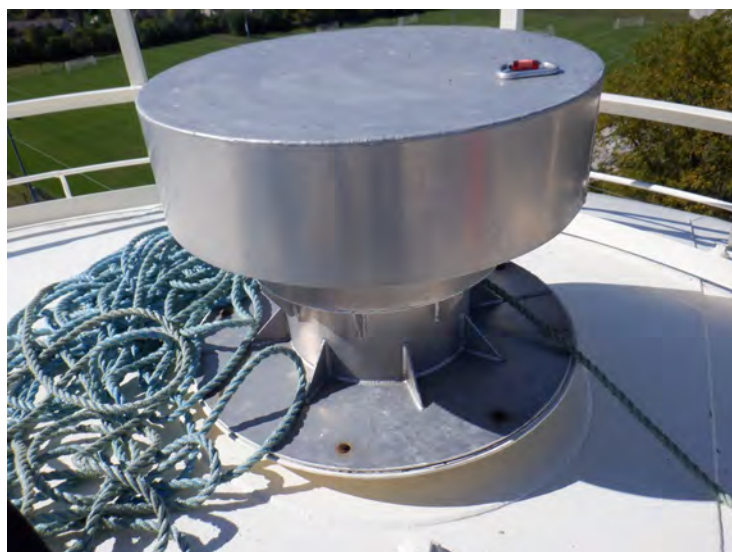
21) The roof vent is in good condition.

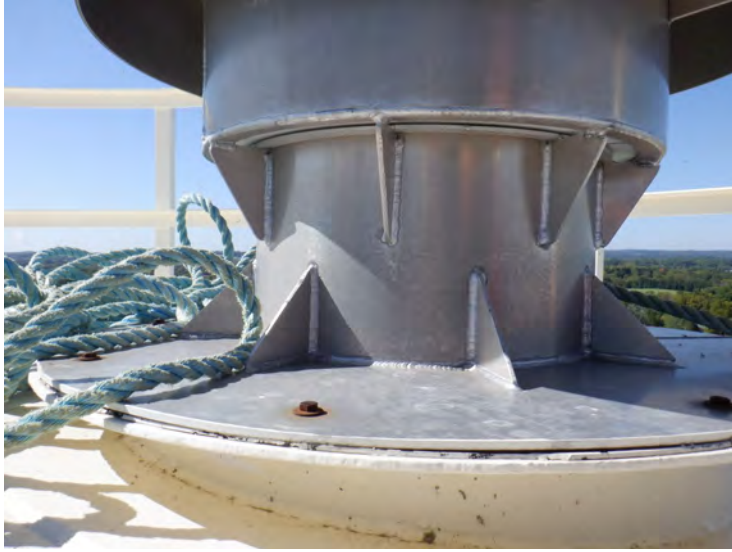
22) The roof vent pressure plate was properly aligned and free to move.

23) The vertical roof vent screen is in good condition.

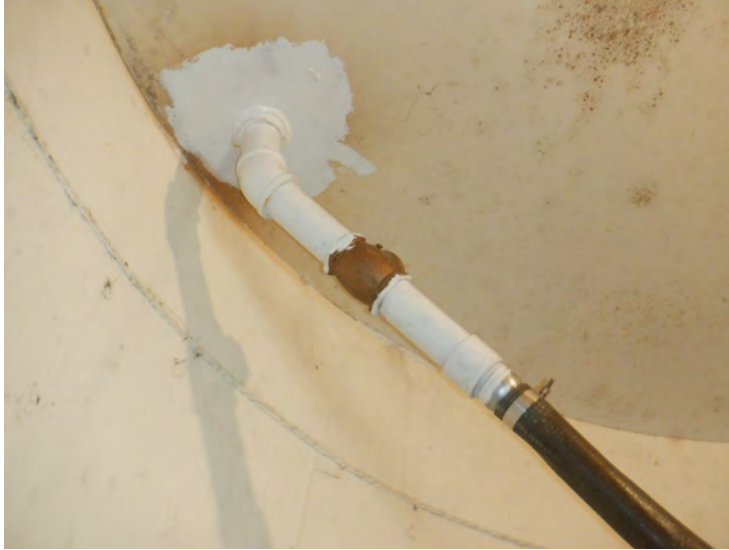
28) There is a check valve on the condensate platform drain.

29) The baseball ladder is in good condition. The ladder is equipped with a fall prevention device.

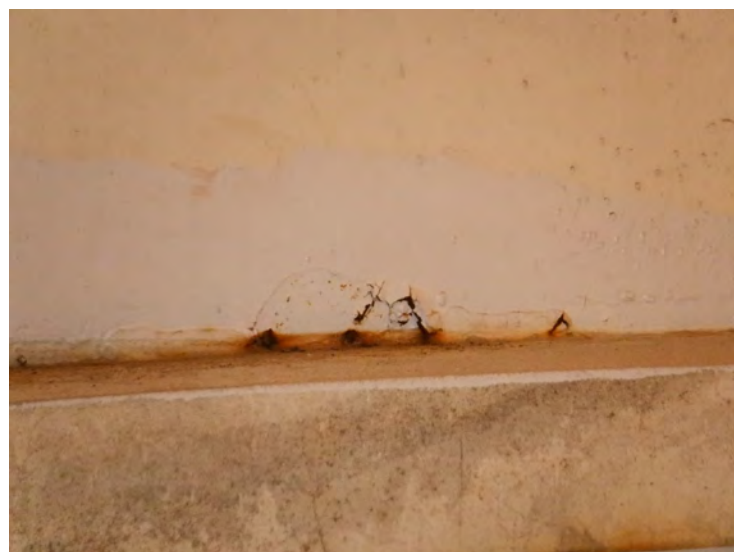
33) Coating failures along a stiffener in the dry riser.

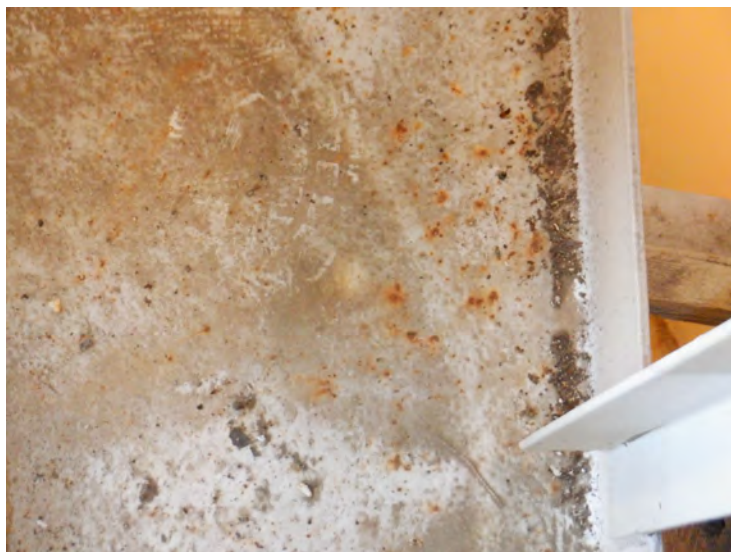
39) Minor coating failures on the top platform.

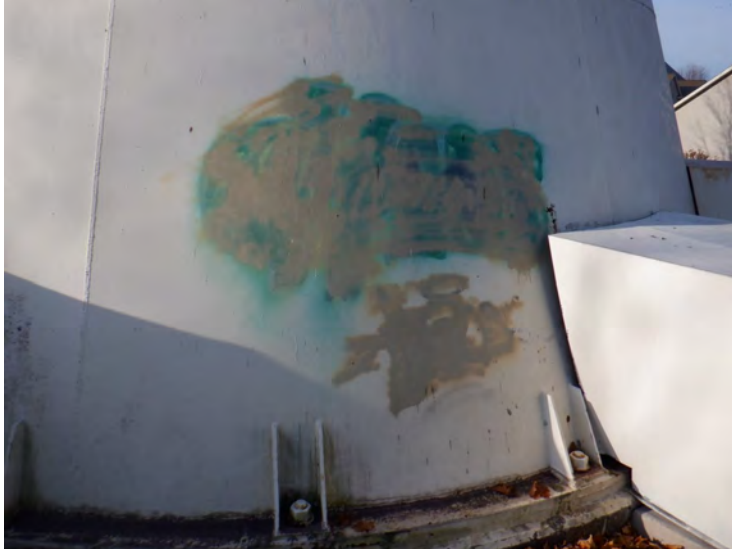
The basebell coating is in fair condition with numerous failures. Primary method of deterioration is spot failures to the substrate with rust undercutting.

7) Coating failures on the basebell.

Remove the existing coating by dry abrasive blast cleaning the steel to a commercial (SSPC-SP6) condition and apply a urethane system. All blast work would be performed inside a dust tight containment system using negative air pressure.

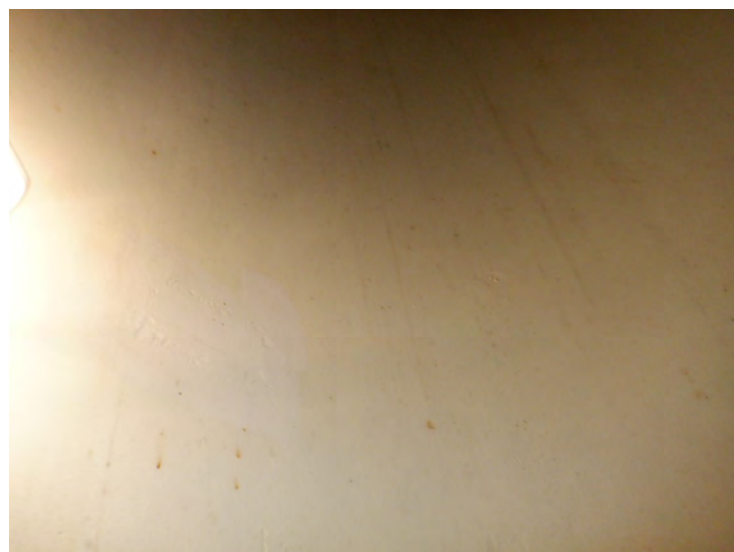
39) The dry riser coating is in good condition overall.

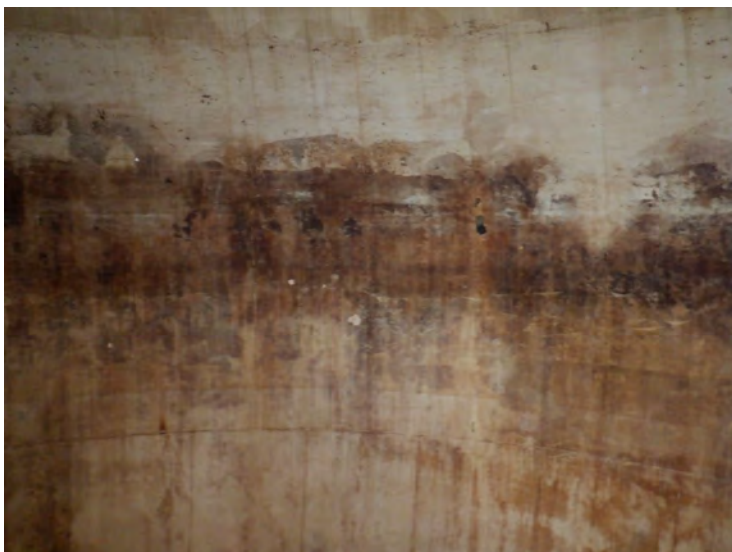
54) The wet interior sidewall coating is in poor condition overall.

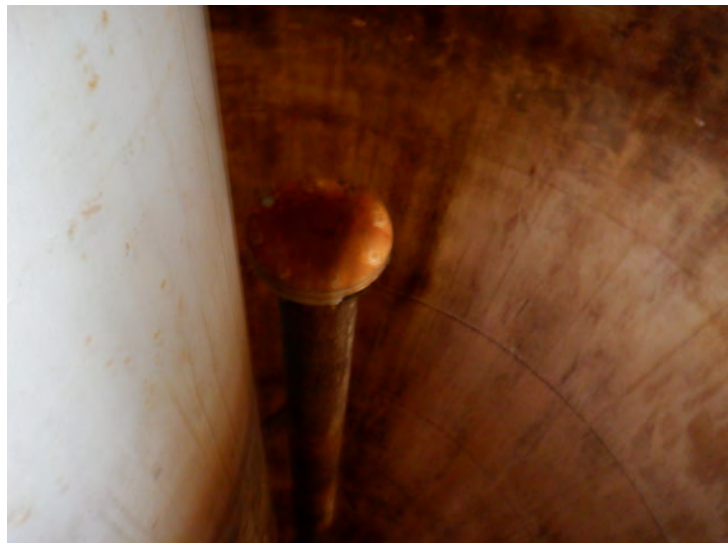
56) There is an abandoned pipe with a blind flange in the wet interior that extends up near the high-water level.

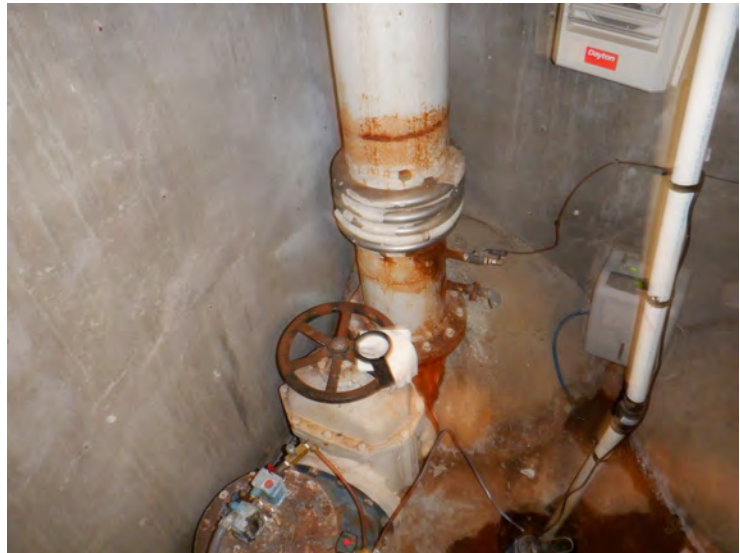
67) Same.

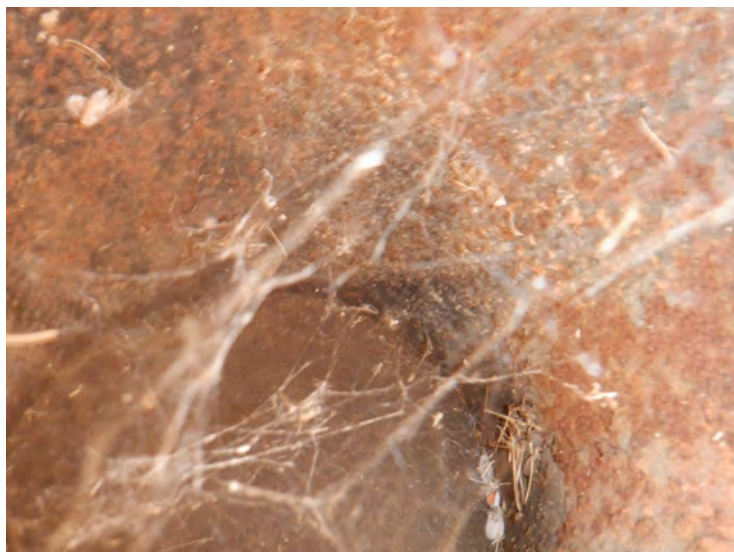
3) The screen at the overflow discharge is intact with no gaps or holes.

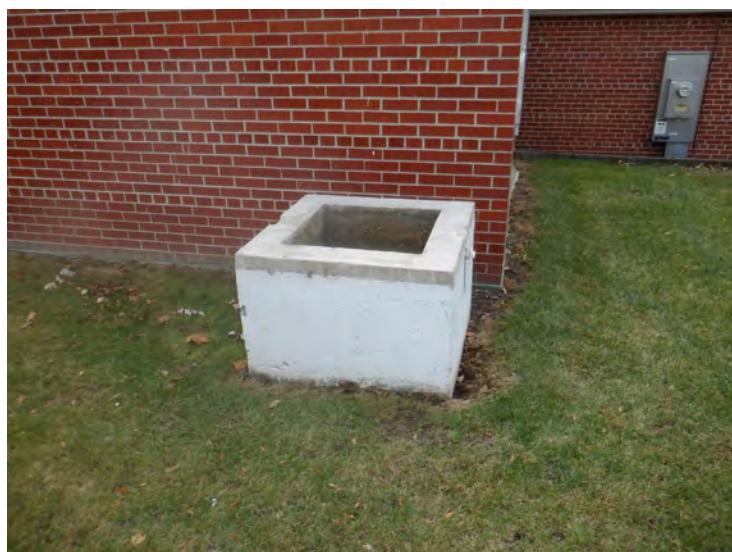
6) The roof hatch curb is more than 24 inches above grade.

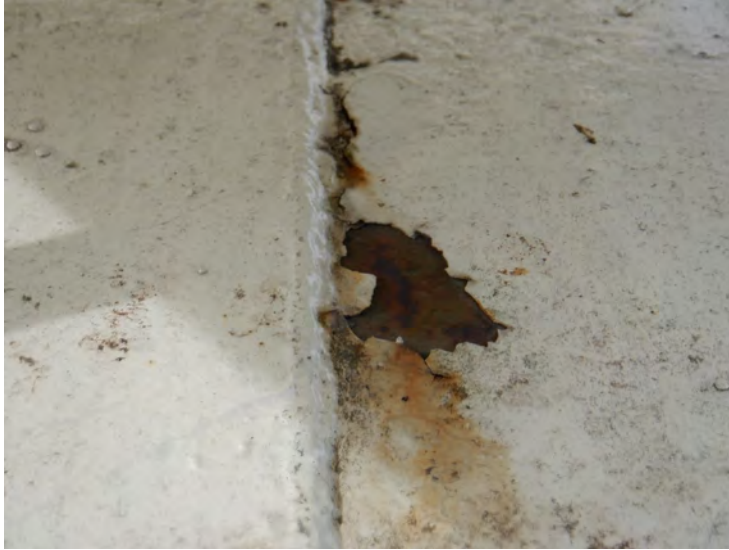
21) Same.

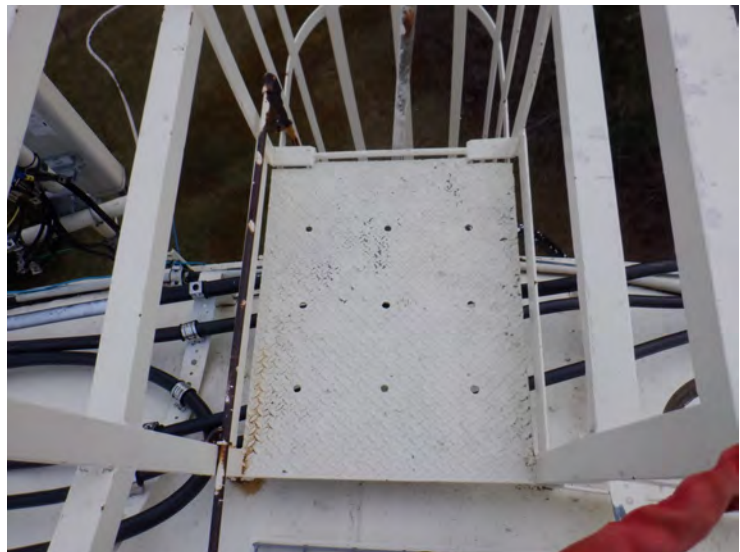
Roof comments: **There is delamination on the center handrail, several scratches in the topcoat at roof edge, antenna spot coating failures that are 1-2 inch diameter under the step off platform**

22) Spot coating failures on the roof.

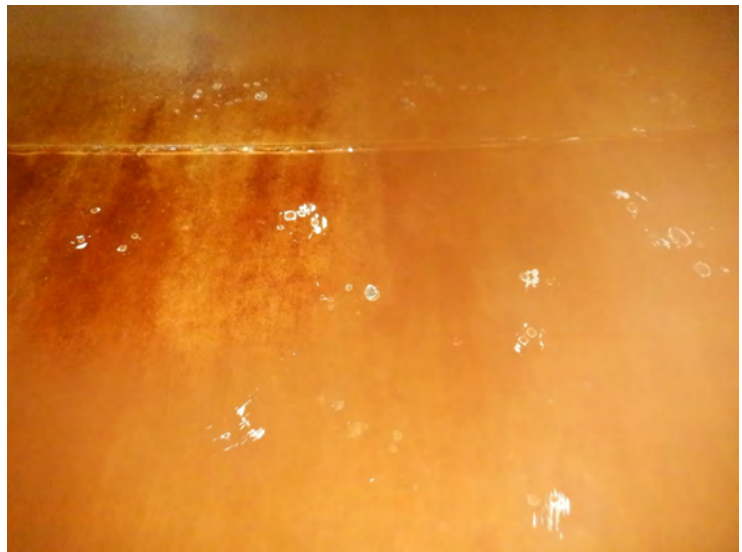
Sidewall comments: There are 200+ blisters with a few broken on the lower sidewall. There are two areas where mineral staining is scraped away to paint, possibly due to ice movement

50) There are blisters in the sidewall coating on the lower sidewall panels.

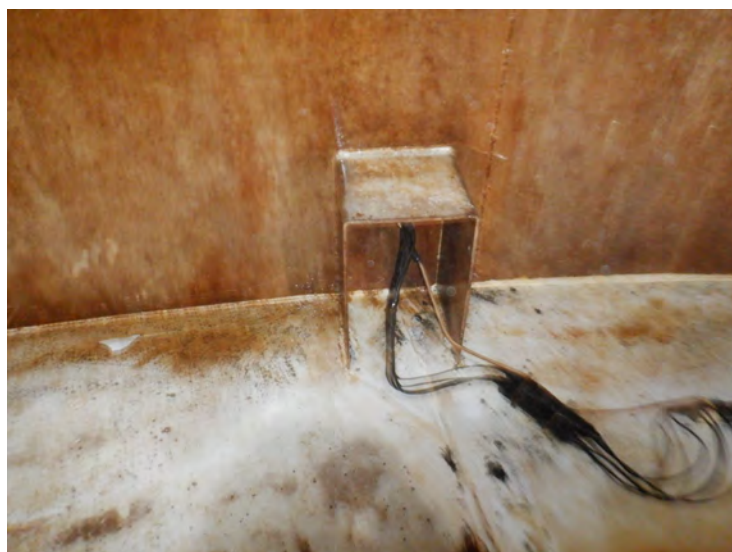
54) The cathodic protection pressure fitting has a deflector plate around it.

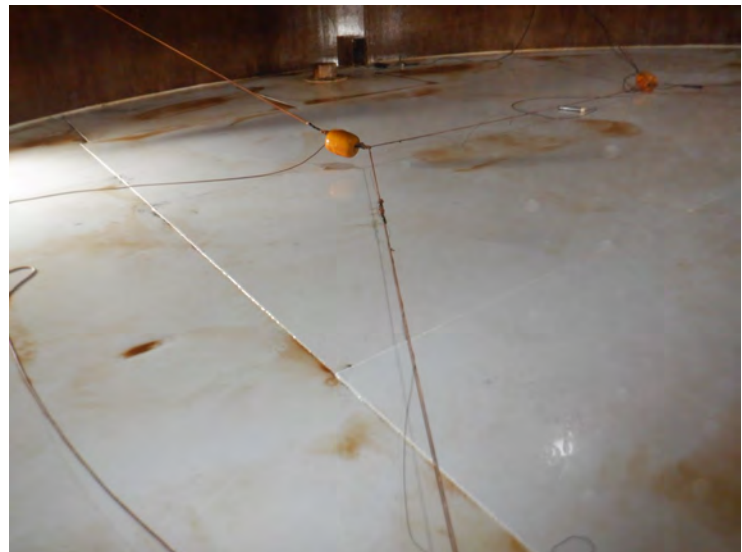
59) The cathodic protection system appears to be in good condition.

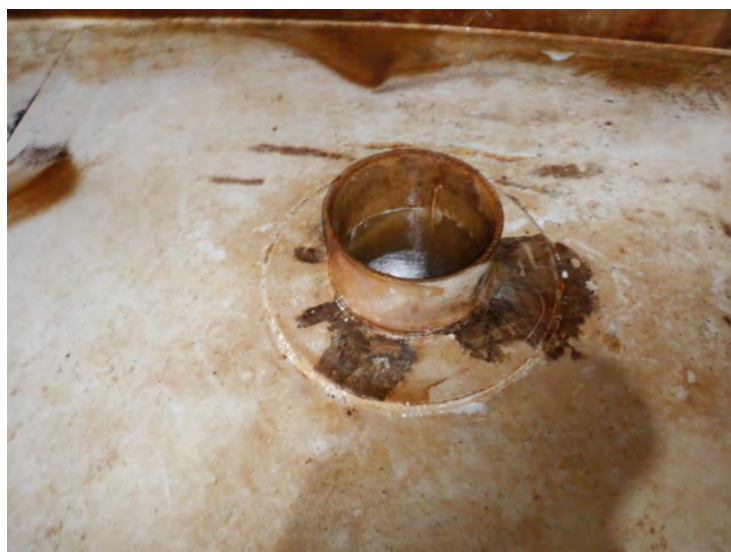
60) The fill/draw pipe is in good condition. There is not a deflector plate or bar over the top of the pipe.
