Water System Master Plan

April 2022

PREPARED FOR:
Village of Pewaukee
235 Hickory Street
Pewaukee, WI 53072

PREPARED BY:
Ruekert & Mielke, Inc.
W233 N2080 Ridgeview Parkway
Suite 300
Waukesha, WI 53188

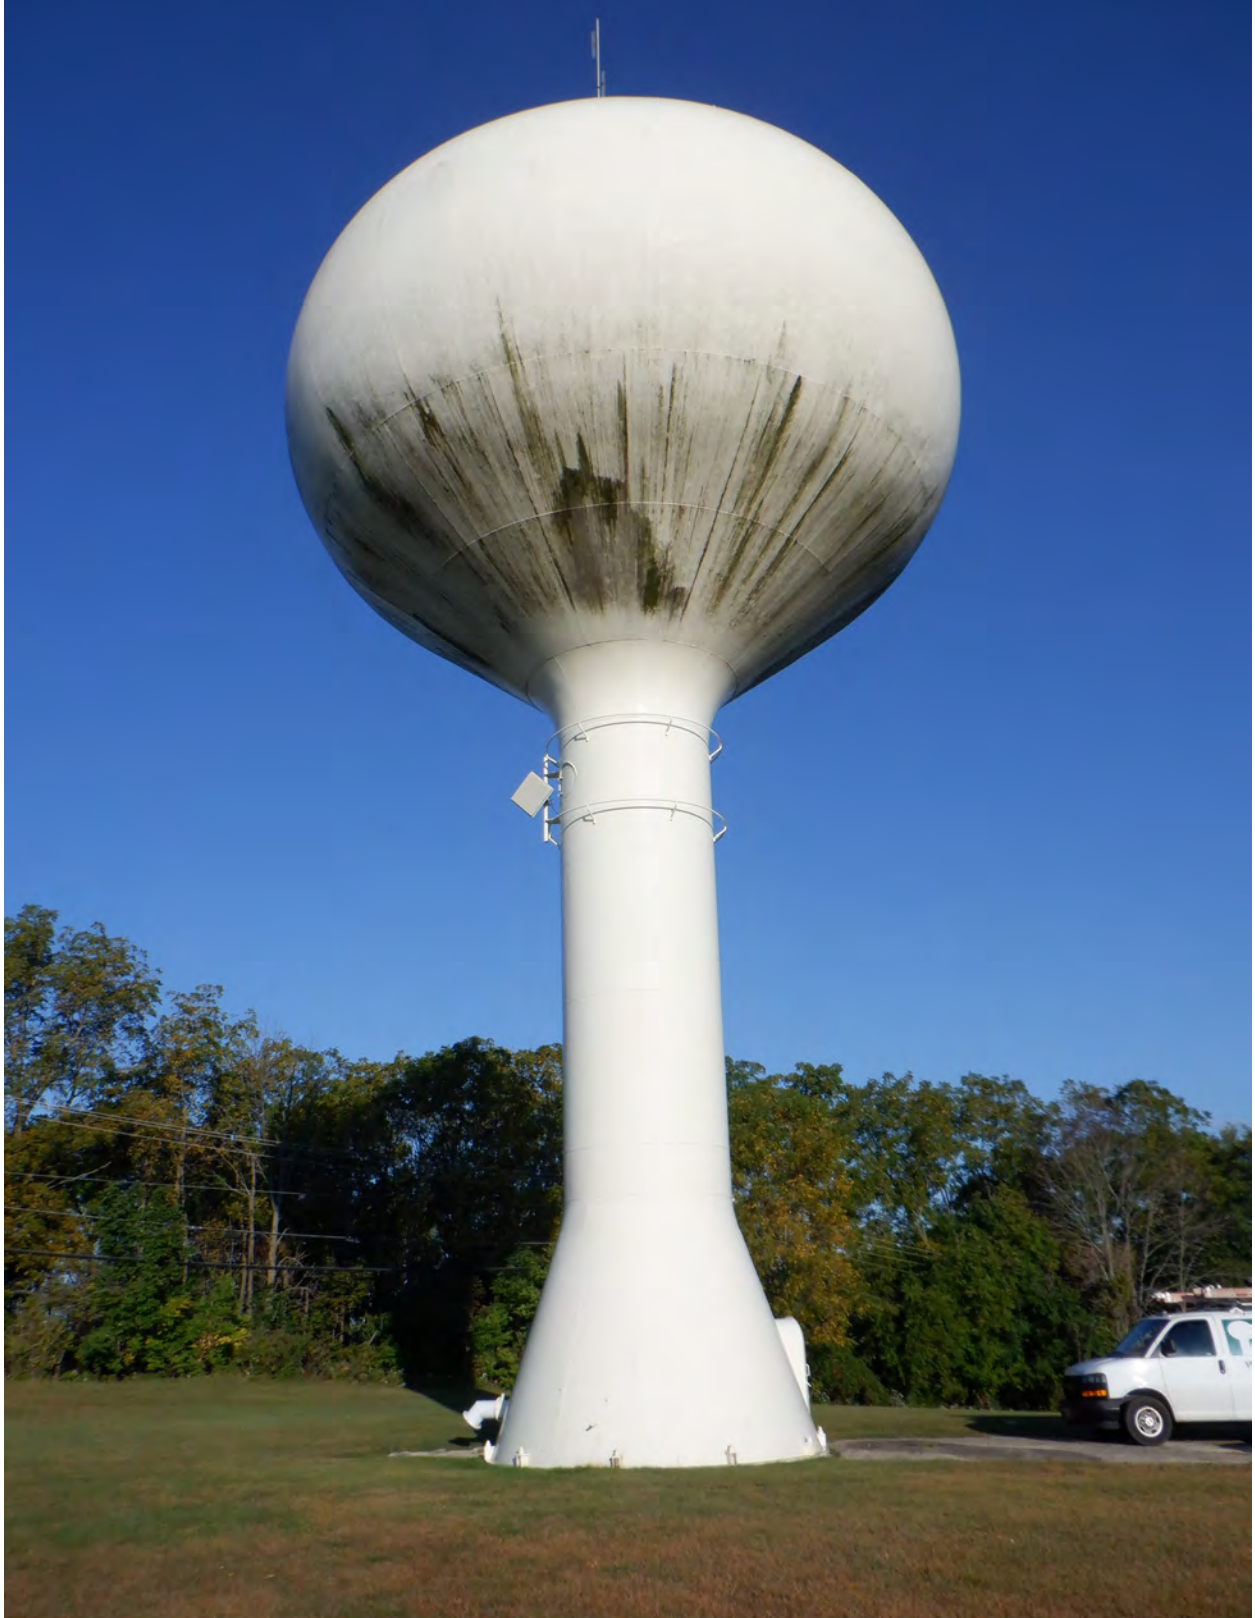
250,000 gallon spheroid (Lake Street) elevated water storage tank owned by the Village of Pewaukee, Wisconsin.

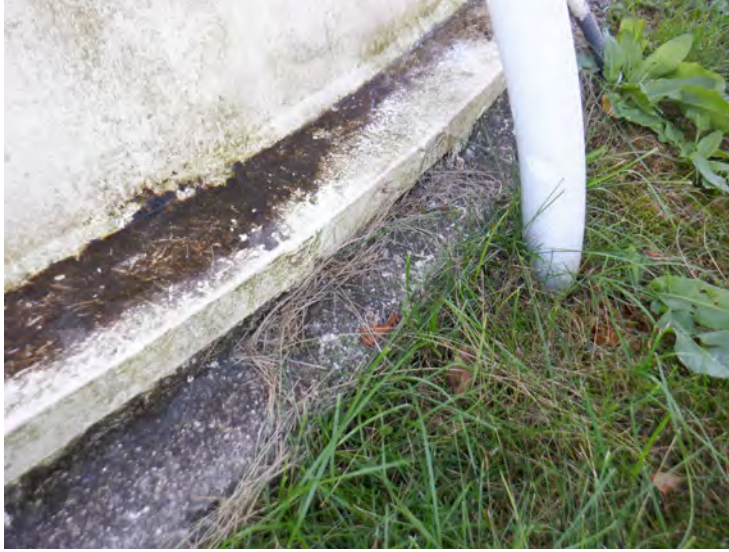
1) The concrete foundation is in good condition with no significant deterioration.

2) The anchor bolts are in good condition. There is no missing grout between the baseplate and foundation.

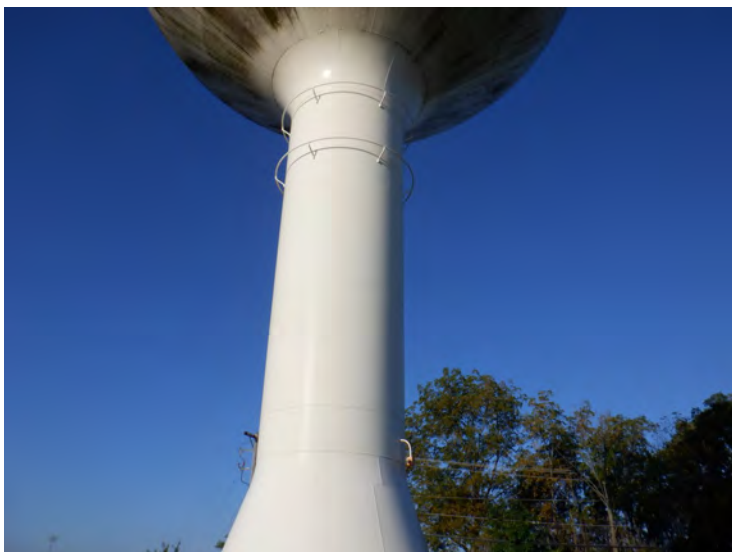
9) Same.

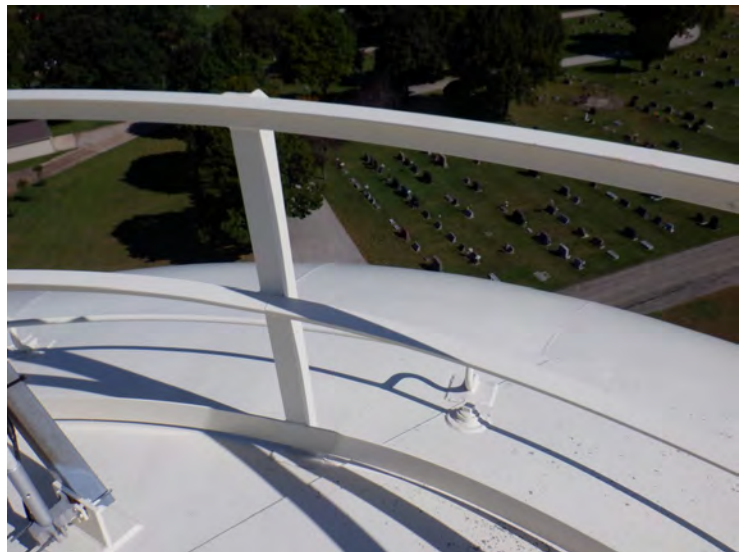
18) The wet interior roof hatch is in good condition. A gasket was installed on the hatch during the inspection.

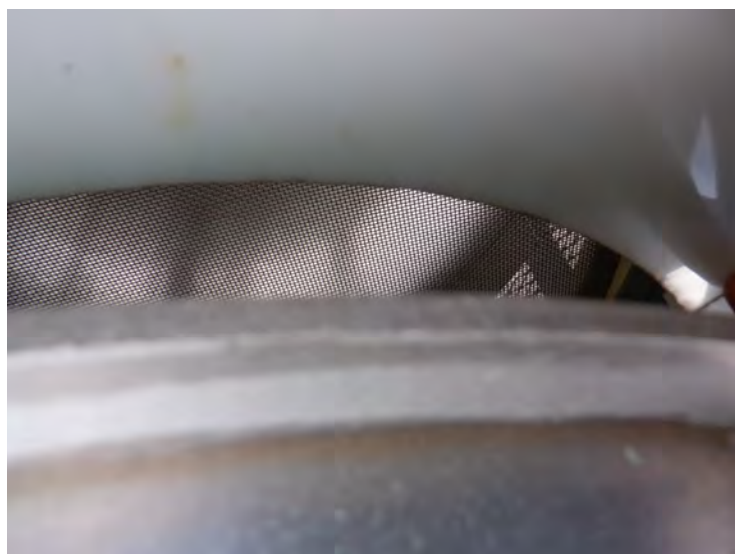
24) The interior roof vent screen is intact with no gaps.

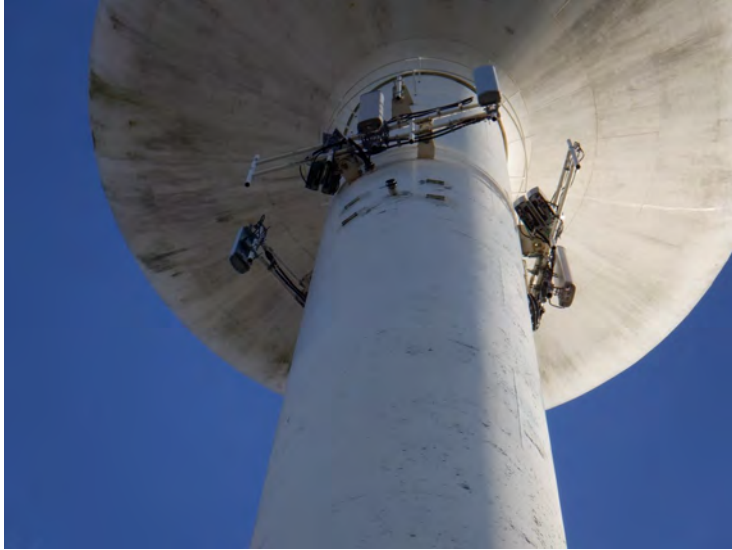
13) Same.

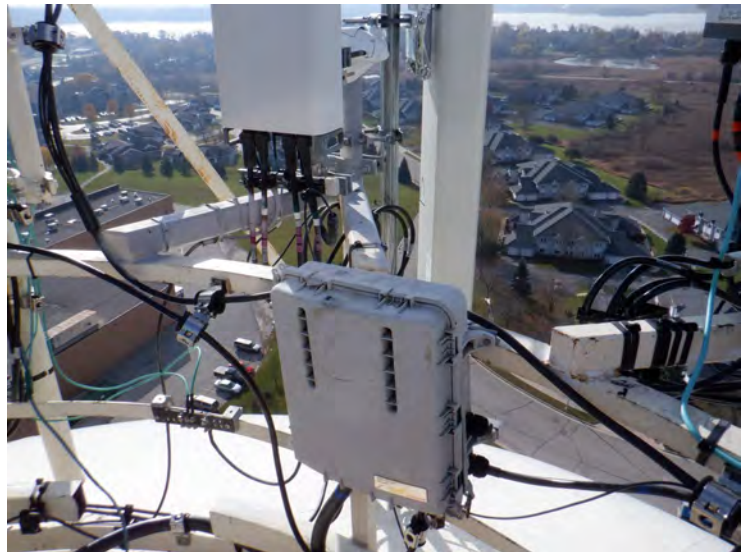
23) The roof handrail is in good condition. There are antennas attached to the roof handrail. There is not a painter's railing on the roof

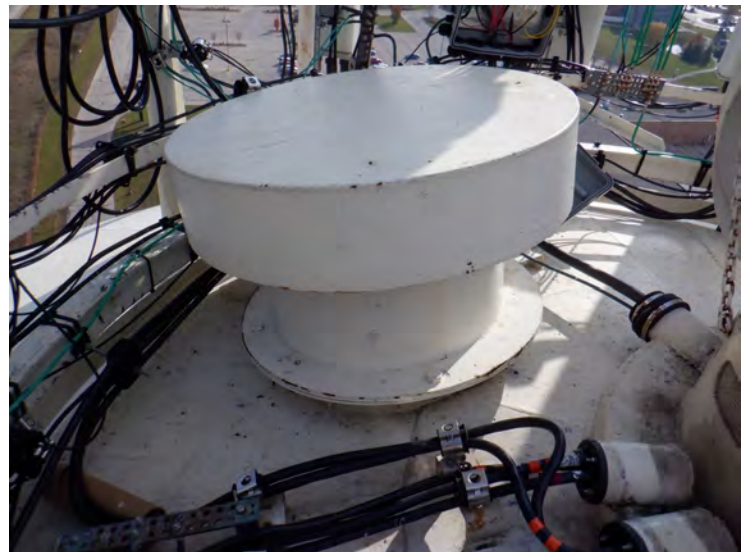
26) The roof vent is in fair condition.

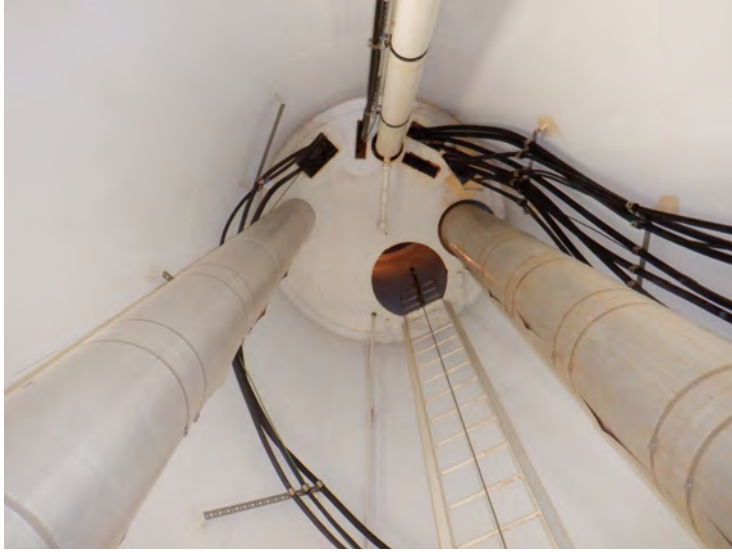
31) Same.

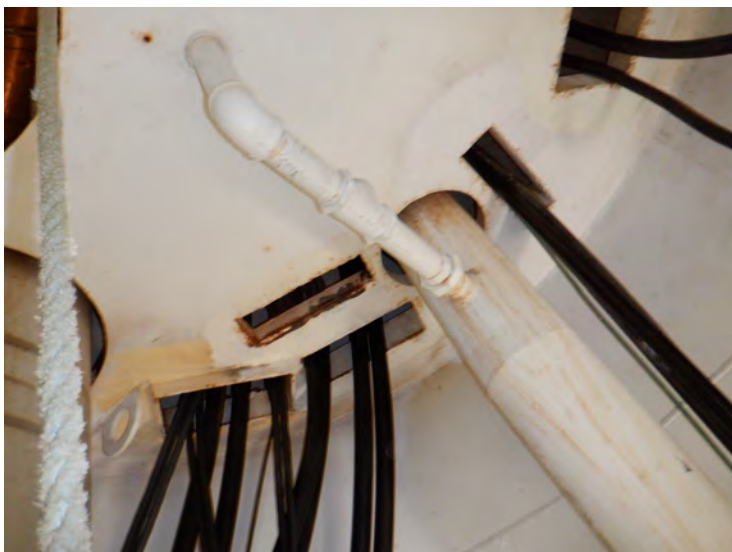
32) The basebell ladder is in good condition. The ladder is equipped with a fall prevention device.

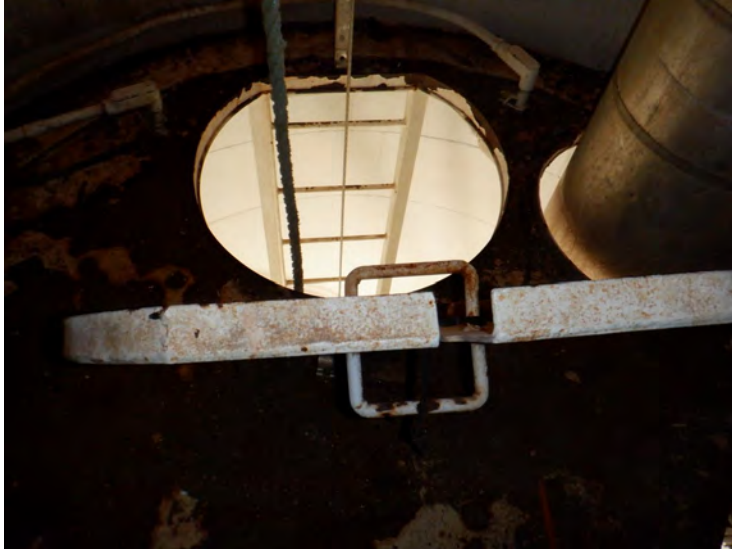
33) There is a check valve on the condensate platform drain.

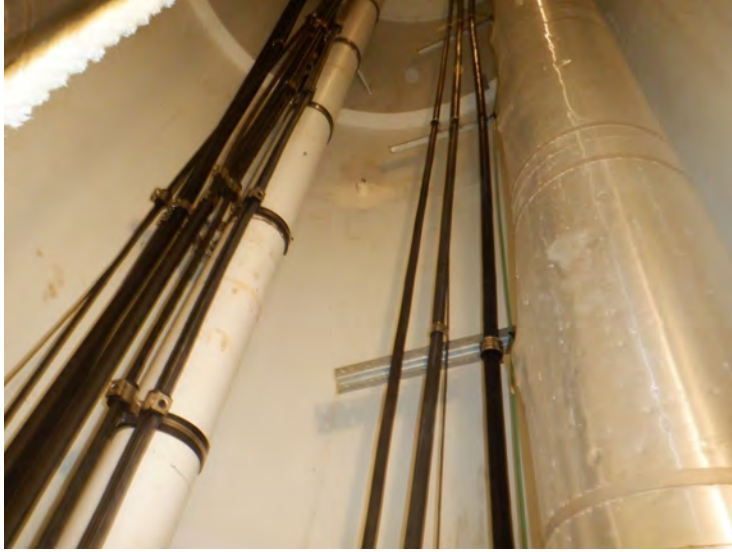
40) The fill/draw pipe insulation and aluminum cover are in good condition.

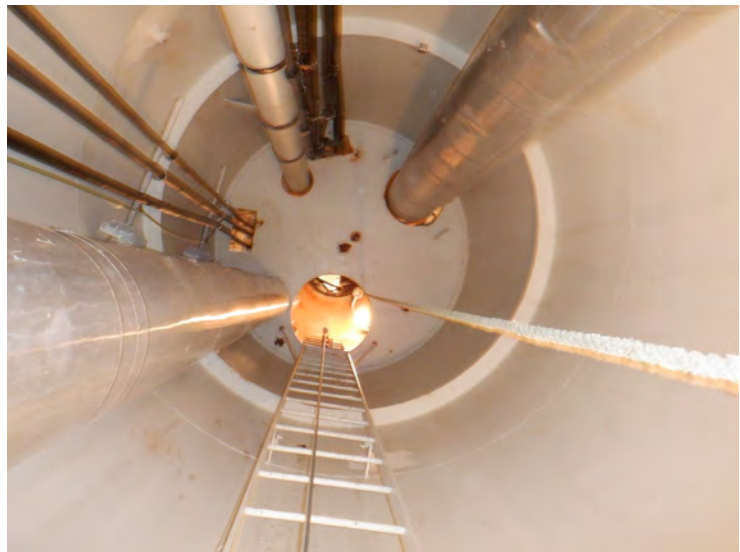
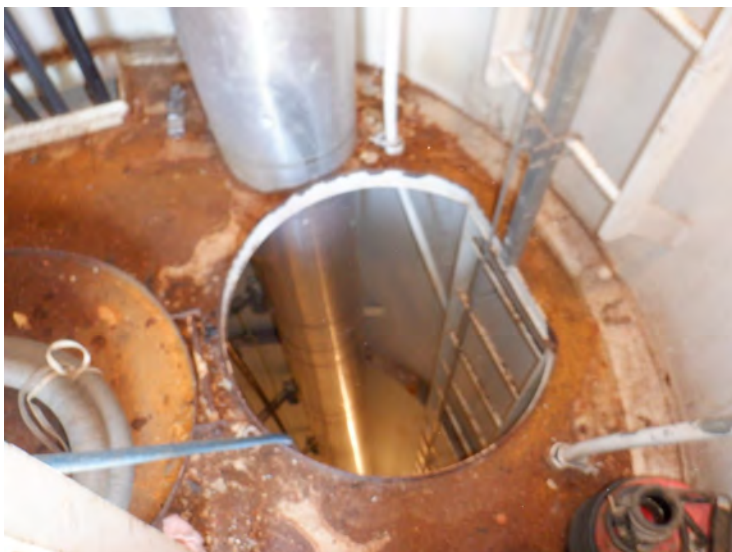
41) The riser ladder is in good condition. The ladder is equipped with a fall prevention device.

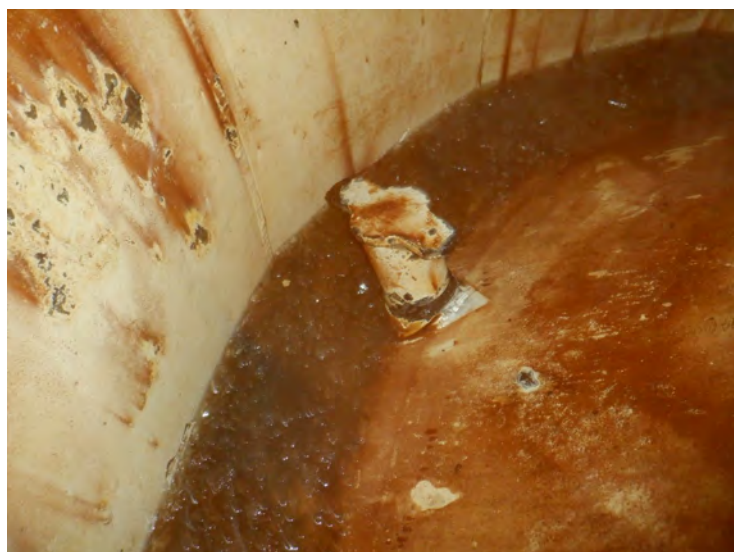
62) Same.

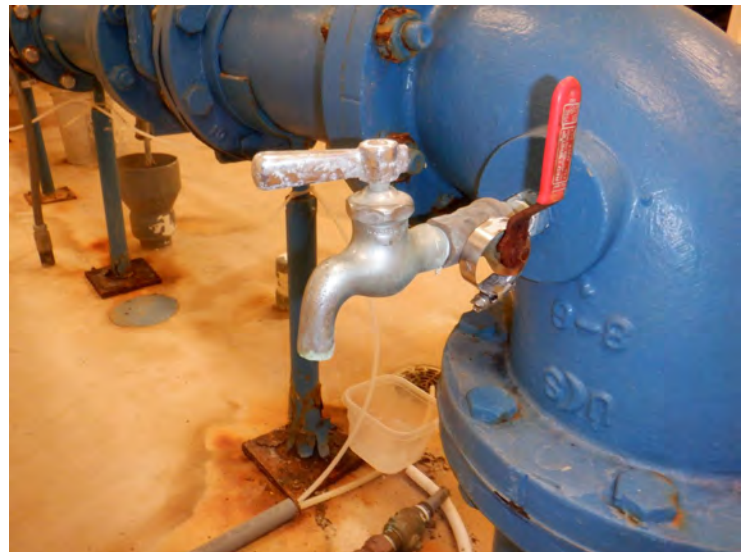
70) Same.

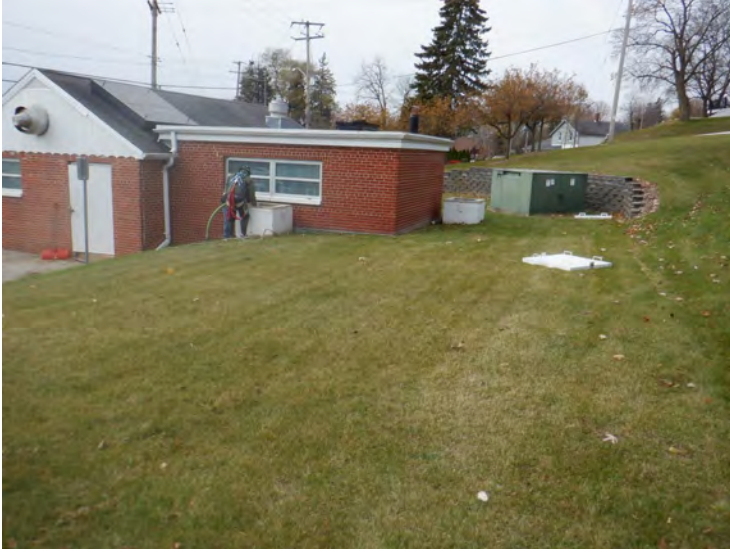
1) 125,000 gallon underground concrete water storage reservoir (Well 2) owned by the Village of Pewaukee, Wisconsin.

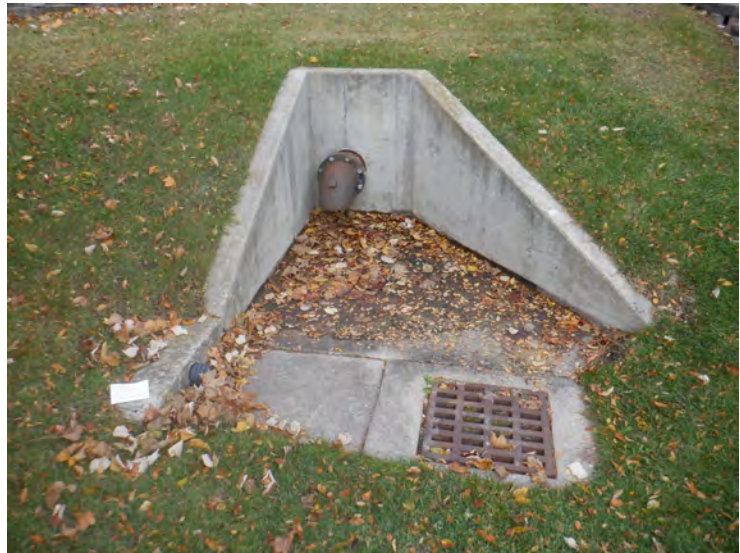
2) The overflow pipe discharges to a catch basin.

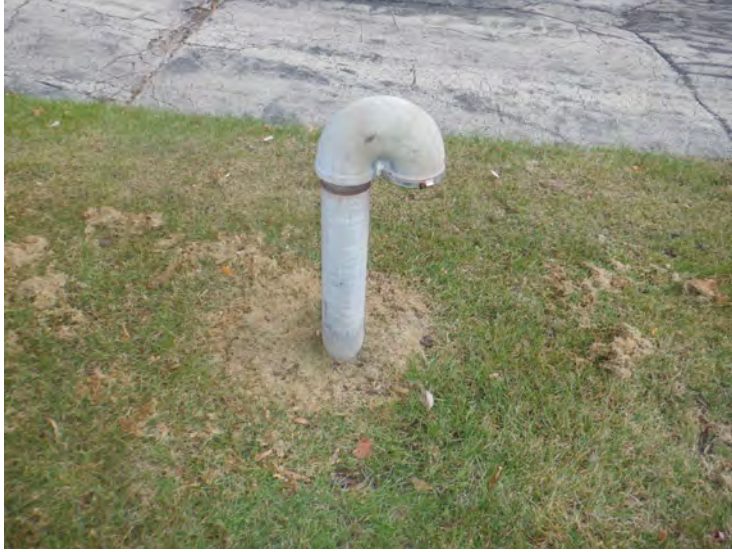
4) The goose neck roof vent is in good condition.

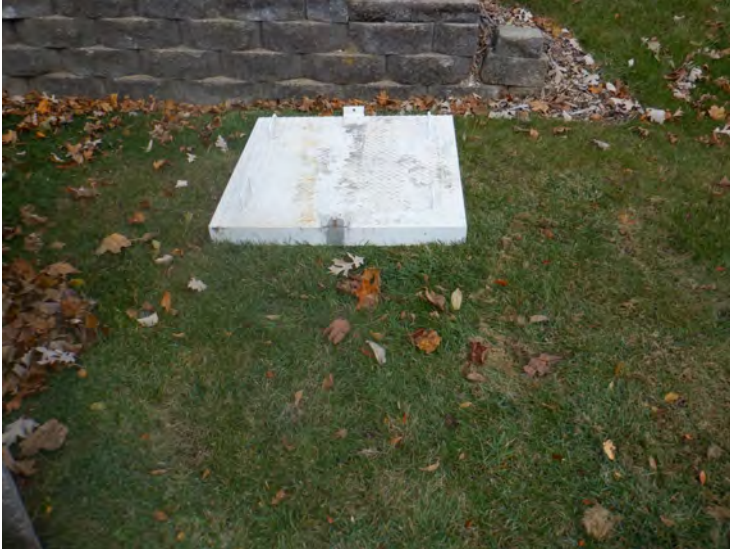
7) The roof hatch covers are in good condition with some coating erosion.

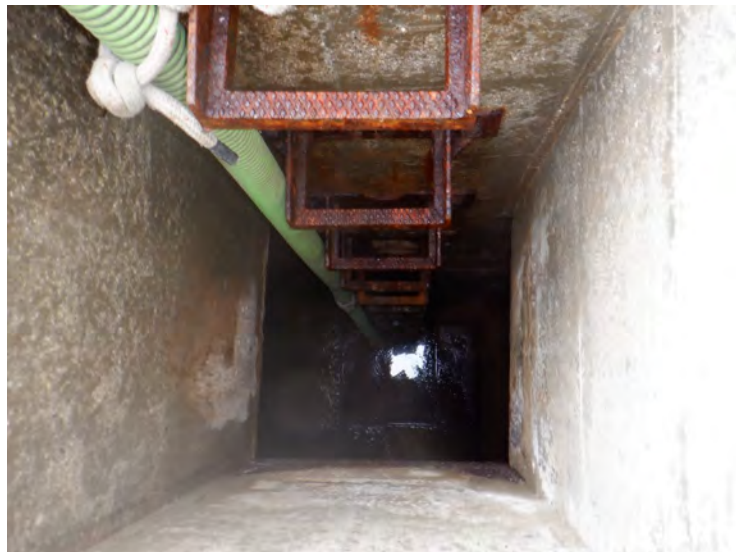
8) The ladder cleats from the roof to the floor are in good condition.

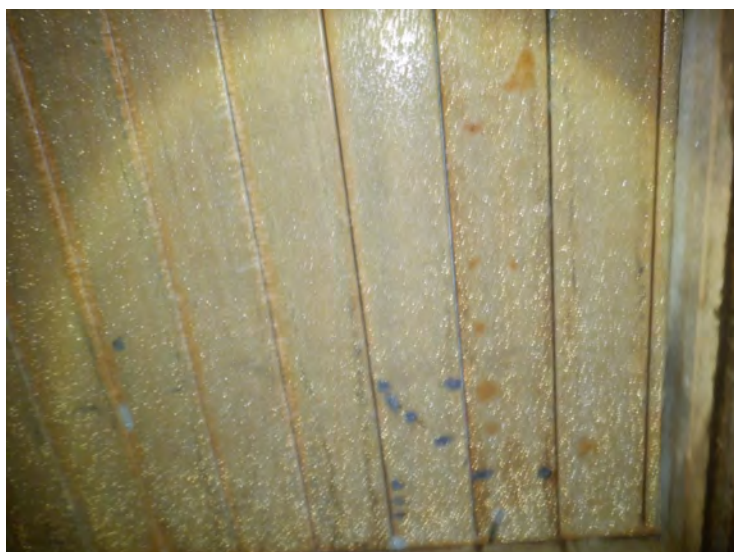
The roof is in good condition overall with no significant deterioration. There is some rusting at the surface from rebar chair bases and rebar.

9) Rusting at the surface of the wet interior roof.

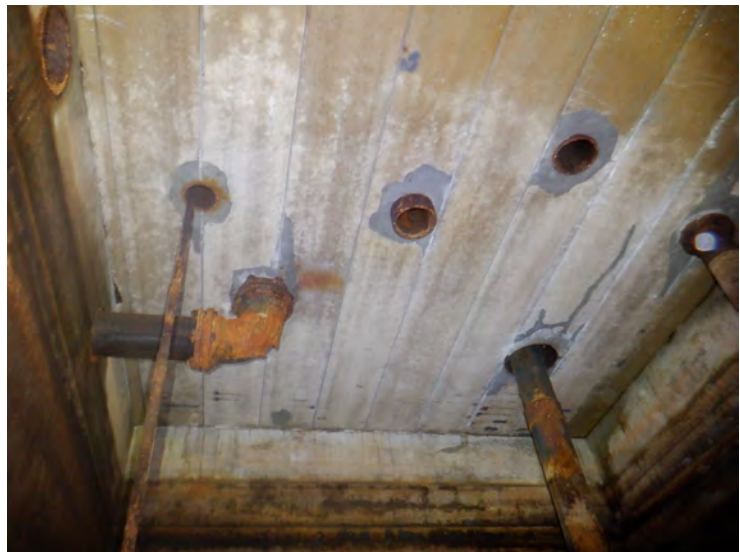
11) The fill pipe stubs at the wet interior roof.

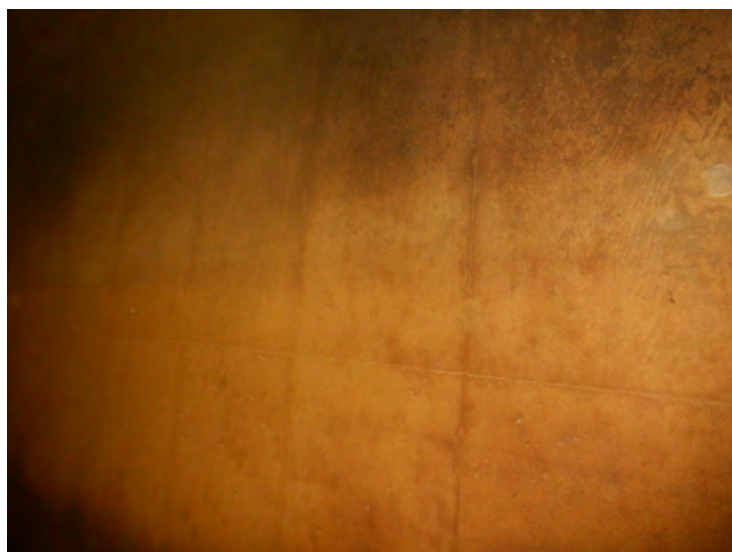
12) The concrete sidewalls are in good condition with no significant deterioration.

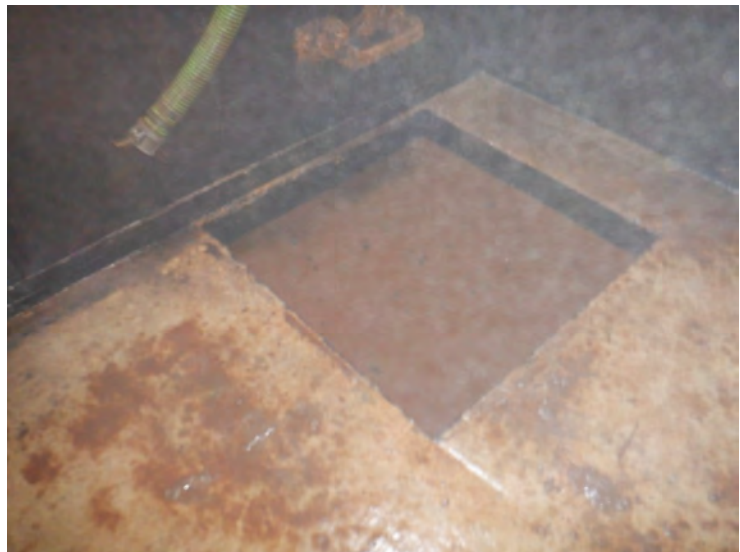
17) There is no deterioration of the concrete floor.

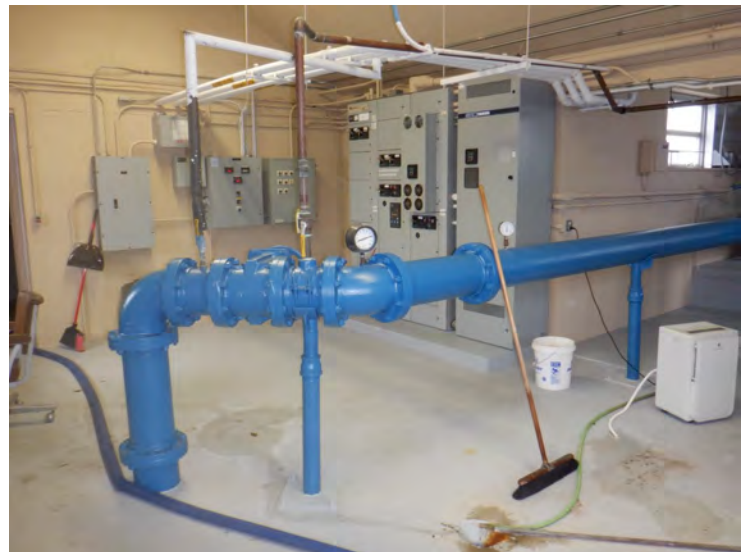
20) Same.

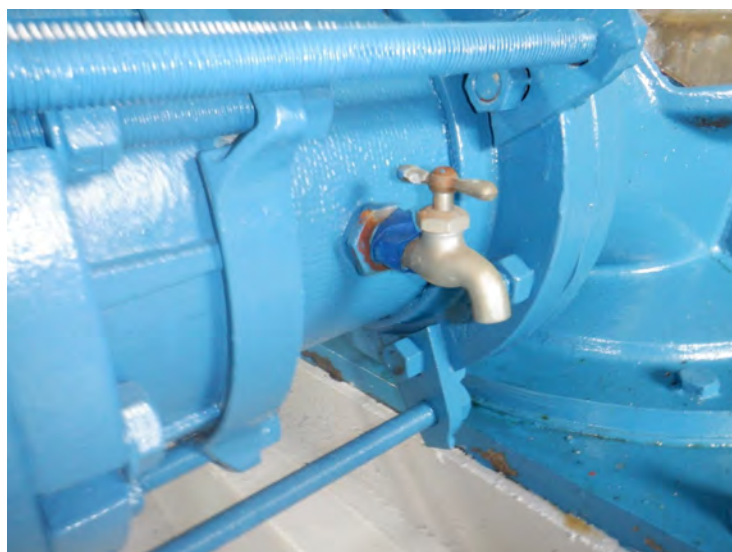
21) The sample tap in the pumphouse is in good condition.

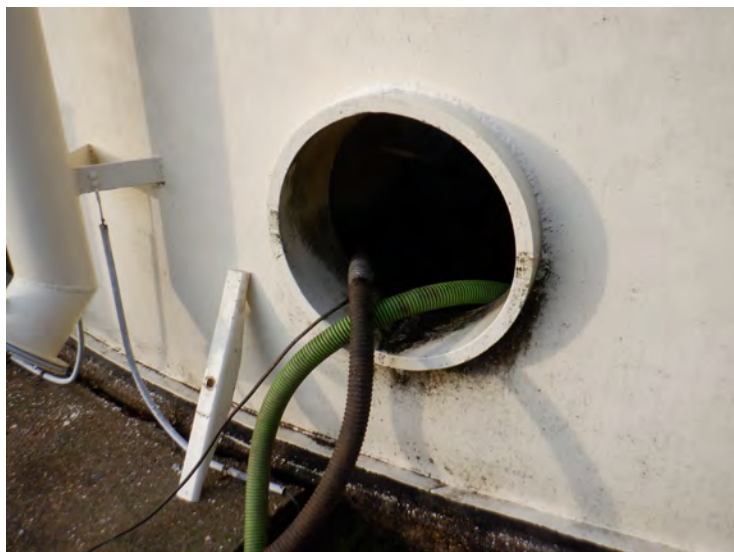
8) The two sidewall manways are in good condition.

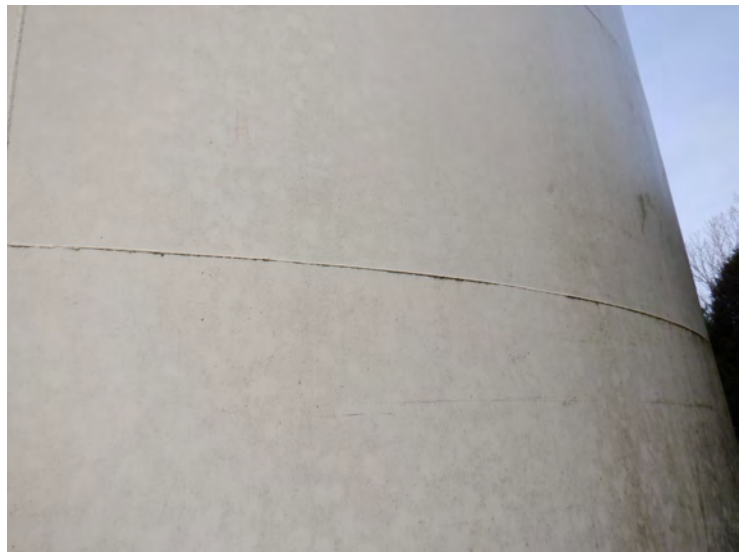
13) The coating on the sidewall is in good condition overall.

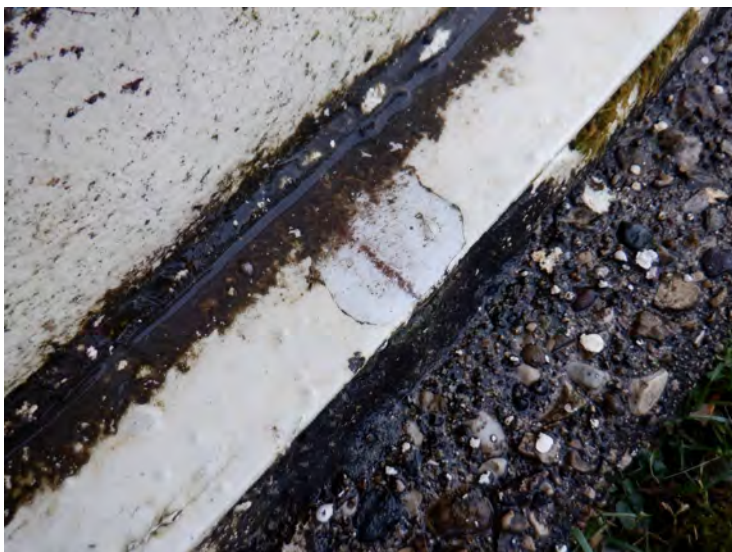
14) Same.

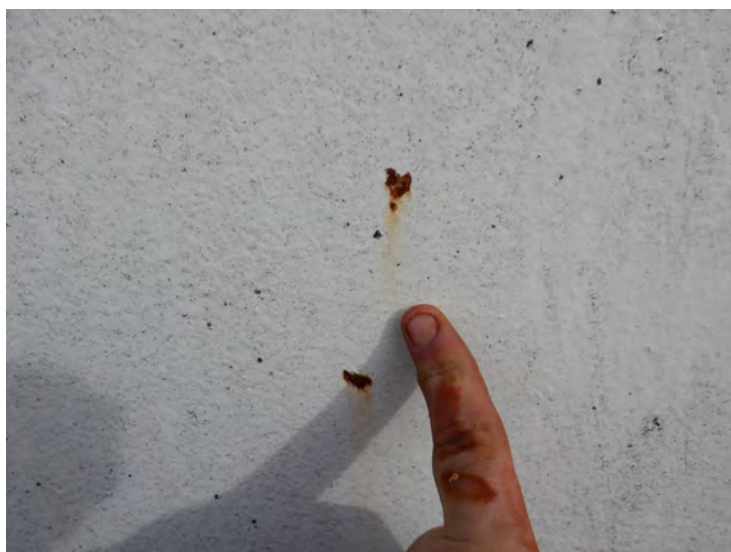
Sidewall comments: **There are approximately ten small spot coating failures that are ¼ inch diameter or less and one spot of delamination that is 2 inch diameter on the baseplate**

17) Same.
